## [Inspecting the Lunar Rover]

**Stock#:** 67572  
**Map Maker:** NASA

**Date:** 1971 circa  
**Place:** n.p.  
**Color:** Color  
**Condition:** VG+  
**Size:** 8 x 7.5 inches

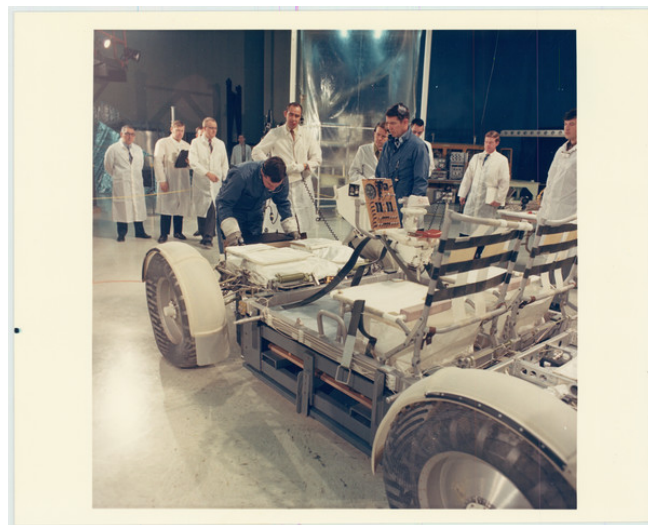
Presented is an image of the lunar rover taken at its design or testing facility. This rover appears to be newly completed and in mint condition. In the background, several scientists, engineers, and management personal are inspecting the rover. This was a test module, as the non-flight insignia above the heading on the control panel reveals (visible on other photos of the same rover).

Visible on the control panel pictured are many instruments, which manuals and other photographs help to decode. On the left side (black, outside the main panel) is an attitude indicator, indicating steepness of terrain. To the right of that is the Integrated Position Indicator which shows heading, bearing, range and distance covered. Due to the lack of magnetic field on the moon, this navigational system would have needed to use gyroscopes, similar to those used in flight. This would have been calibrated by the sun shadow device, located just to the right of the IPI. In addition to navigational devices, a plethora of switches and steering devices are included on the control panel.

Which part of the inspection or assembly is taking place is difficult to understand. Everyone is watching as an engineer in a blue coat lowers something into the front of the vehicle while wearing thick insulating gloves. Other photos show additional components added to the vehicle, supporting the idea that this image shows the assembly phase. Cross-referencing this part of the rover with a manual for the vehicle, it could either be part of the power system, navigational equipment, or payload interface. A battery component would explain the need for insulating gloves.
